NBS SPECIAL PUBLICATION **592**

# An Investigation of the Miyagi-ken-oki, Japan, Earthquake of June 12, 1978

Bruce R. Ellingwood, Editor

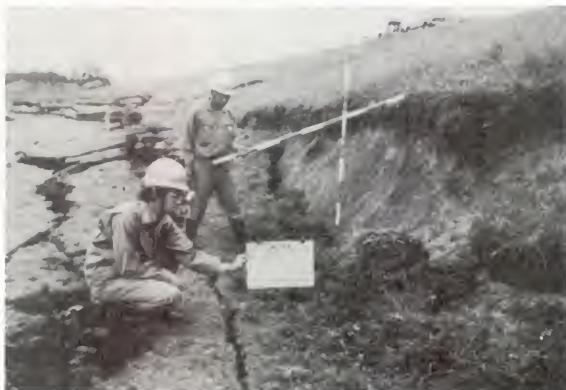
At Site 1, liquefaction caused slumping, lateral spreading, and settlement of up to 1.5 m along a 160-m-long section of the dike (Figures 8.2, 8.3, and 8.4). Longitudinal cracks several tens of meters long opened in the dike crest. Between the dike and the river, fissures striking obliquely to the dike formed, and sand was ejected from them (Figure 8.5). Other fissures trending parallel to the dike and the river formed near the river bank, more than 100 m from the base of the dike. The occurrence of fissures and sand boils in ground away from the dike indicates that liquefaction took place primarily in material beneath the dike and not in the dike material itself.

**Figure 8.3** Site 1, Natori River. Slumping of dike on flank away from river. View north. (Photo courtesy Tohoku Regional Construction Bureau)

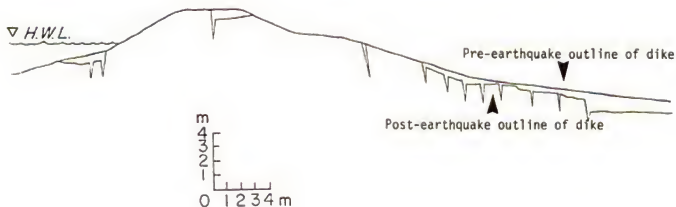
Figure 8.4 Site 1, Natori River--cracking, settlement, slumping, and lateral spreading induced by liquefaction. (From Tohoku Regional Construction Bureau, MOC, unpublished data)

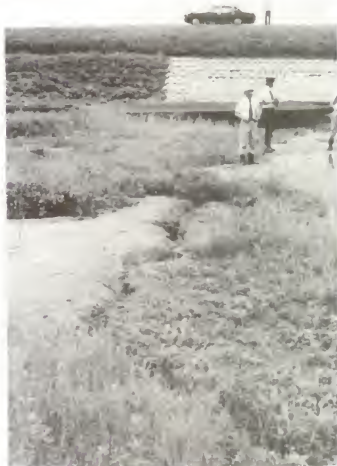
Figure 8.5 Site 1, Natori River. Liquefaction-induced cracks and sand boils in ground between river and dike indicate that liquefaction took place in materials beneath the dike. Sand in center-ground to left of crack is from sand boil. Sand bags on dike were placed after the earthquake as a repair measure. View is south.

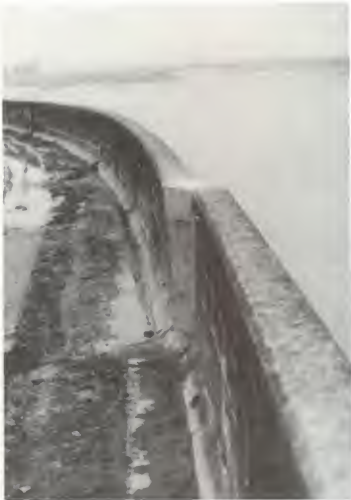
Figure 8.6 Site 2, Natori River. View is west along repaired portion of dike. Note patch across offset in retaining wall offset caused by lateral spreading during earthquake. Retaining wall rises approximately 1 m above roadway.

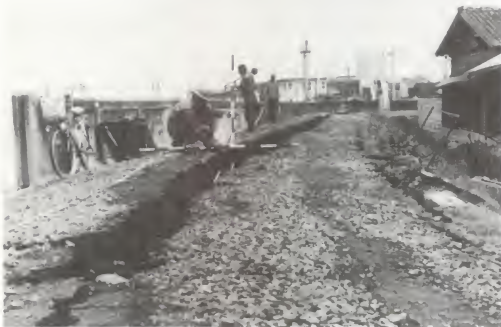
At Site 2 (Figure 8.1), the dike is contained by a concrete retaining wall (Figures 8.6, 8.7, 8.8, and 8.9). A section of the retaining wall several hundred meters long moved about 30 cm toward the river. Longitudinal fissures opened in the dike behind the retaining wall and in a concrete pavement along part of the dike. The dike also settled by as much as 30 cm. This site, at the mouth of the river, is underlain by at least 20 m of sand (Hase, 1967).

Figure 8.7 Site 2, Natori River. Settlement, lateral spreading, and longitudinal cracking of dike. View is east.  
(Photo courtesy Tohoku Regional Construction Bureau)

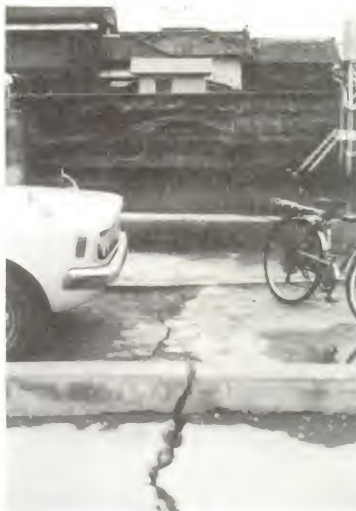
Figure 8.8 Site 2, Natori River. View is west across tributary of Natori River. Dike section shown in Figs. 8.6 and 8.7 is to right of houses in background of this figure. Note crack in concrete pavement in foreground is aligned with crack in retaining wall in background.

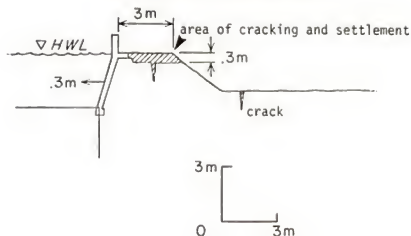
Figure 8.9 Site 2, Natori River--Retaining wall moved laterally and dike crest settled (From Tohoku Regional Construction Bureau, MOC, unpublished data)

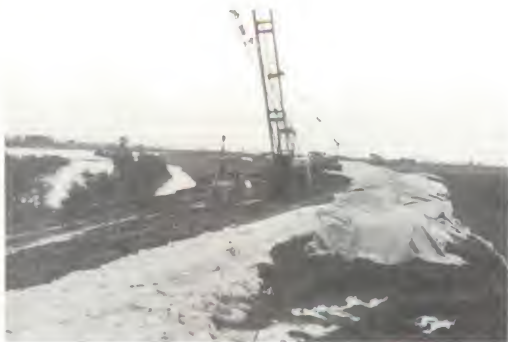
This was one of the most severely damaged sections of dike in Miyagi Prefecture. Settlements of up to 1 m occurred over a distance of 5 km, longitudinal cracks and scraps formed in the dike crest, bulges appeared in the lower slopes, and sand boils occurred along some cracks (Figures 8.10, 8.11, 8.12, and 8.13). The cracks and bulges indicate that lateral spreading and slumping took place. The damaged section rests on the fan-delta of a small stream, and a boring near this site penetrated 15 m of silt, 2 m of fine sand, and 5 m of coarse sand (Tohoku Regional Construction Bureau, MoC, unpublished data; Hase, 1967). Bedrock lies at an average depth of 35 m.

Figure 8.10 Site 3, Yoshida River. View east (downstream) along section of dike where repairs are underway. Dike crest settled as much as 1 m over a length of 5 km. Sand bags have been placed as part of repair process.

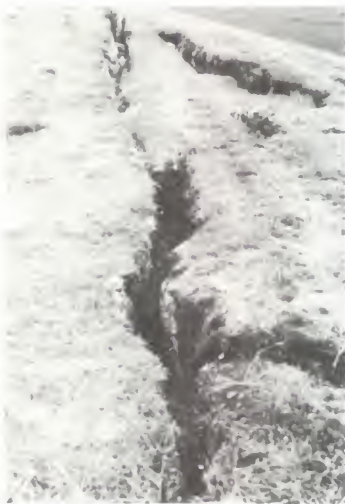
Figure 8.11 Site 3, Yoshida River. Cracks in dike caused by slumping and lateral spreading. Cracks are 10-30 cm wide. View is west. (Photo courtesy K. Kawashima, PWRI)

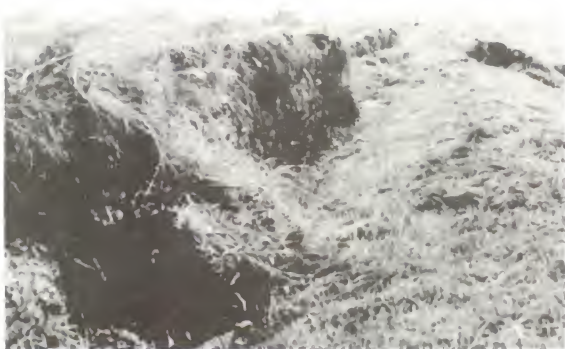
Figure 8.12 Site 3, Yoshida River. Scarps in dike caused by slumping. Note man in background for scale. (Photo courtesy K. Kawashima, PWRI)

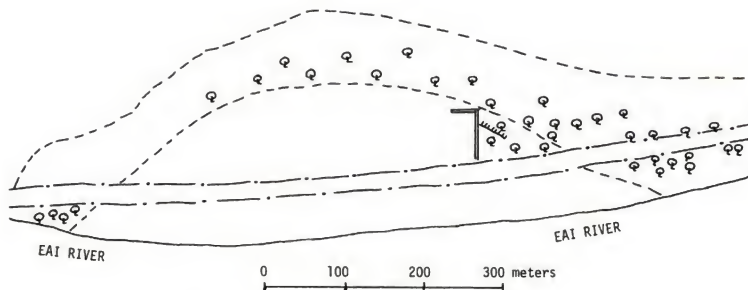
Sand boils were common in an old river channel at Site 4, on the right bank of the Eai River (Figure 8.14). A concrete block fence near this channel was cracked by lateral spreading toward the old channel bank (Figure 8.15). Damage to the dike on this side of the river was minor. Across the river from Site 4, cracks up to 80 cm deep and 10 cm wide occurred in the dike. On both sides of the river, the foundation material contains much soft clay. Some layers of silt and sand may also be present. It was reported that the dikes were built relatively slowly, and significant settlement took place during construction (K. Kawashima, PWRI, oral communication).

Figure 8.14 Site 4, Eai River--Most sand boils occurred in old river channel. Minor cracking of dike apparently occurred where dike crosses old channel, but cracks were repaired prior to visit. (After Tohoku Regional Construction Bureau, MOC, unpublished data)

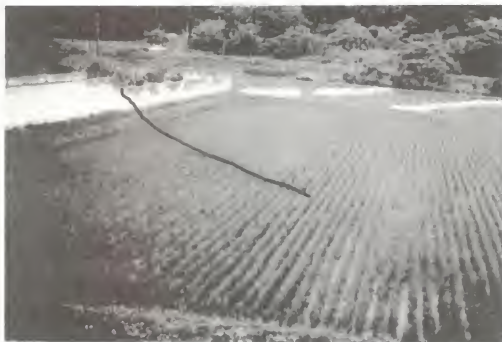
Figure 8.15 Site 4, Eai River - View southwest from crest of dike. Crack (indicated by heavy line) in fence and rice field caused by lateral spreading toward bank of old channel in background.

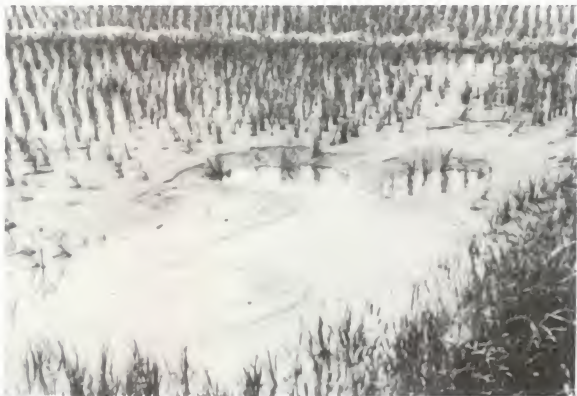
Figure 8.16 Site 5, Old Kitakami River - Sand boils in rice field. Plants are several centimeters tall. Damage to the dike at this site was minor. (Photo courtesy K. Kawashima, PWRI)

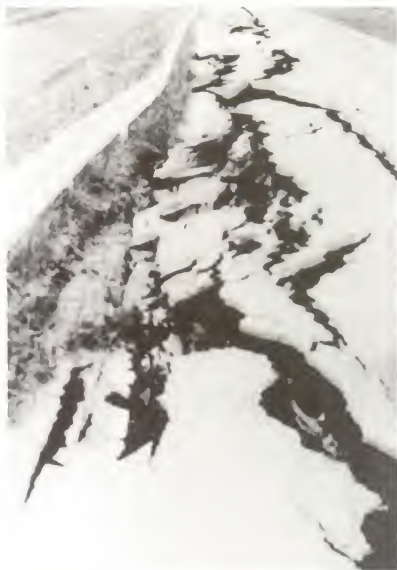
The dike and paved roadway at Site 6 settled up to 1.5 m and cracked over a distance of 4 km (Figures 8.17 and 8.18), and sand boils formed on both flanks of the dike, which is built over an old river channel. According to data from borings completed by the Tohoku Regional Construction Bureau, MC, the soil under the damaged part of the dike is similar to the soil under an adjacent, undamaged section. To a depth of 8 in, the soils consist of gravels, sands, and silts with a few thin layers of clay. *N*-values (blows/foot from a standard penetration test) for most soil layers under both sections are less than 10. Reasons for the differences in behavior between damaged and undamaged sections are currently under study by Japanese engineers.

Figure 8.18 Site 6, New Kitakami River. Cracking of dike crest and roadway due to liquefaction-induced slumping. (Photo courtesy K. Kawashima, PWRI)

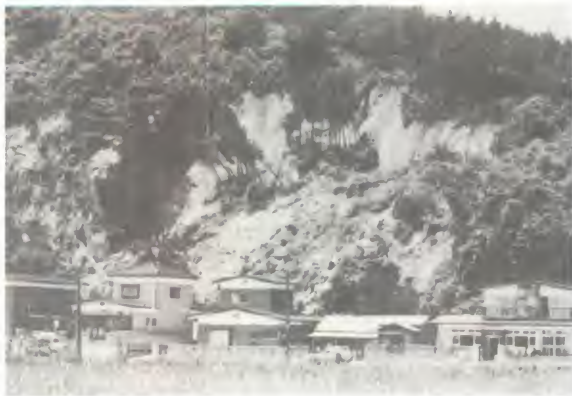
**Figure 9.2** Rock fall on steep slopes of Miocene pumiceous tuff breccia near Takayamasuita. This rock fall damaged four houses close to the base of the slope. (Photograph courtesy of Y. Tsuruya, Slope Protection Division, Ministry of Construction).

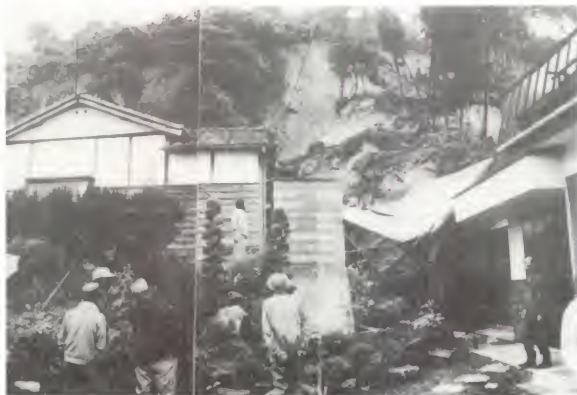
**Figure 9.3** Closeup of rock fall damage to houses shown in left portion of figure 9.2. (Photograph courtesy of Y. Tsuruya)

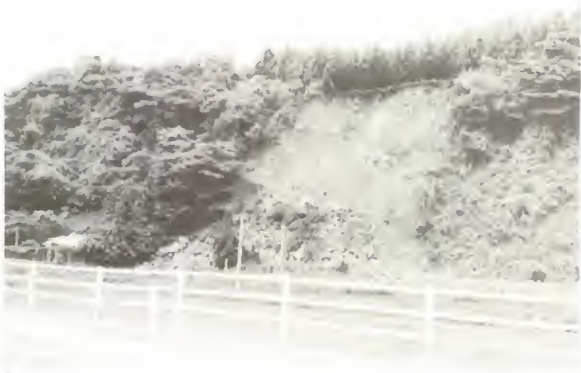
Figure 9.4 Rock fall on steep slopes in volcaniclastic sediments.

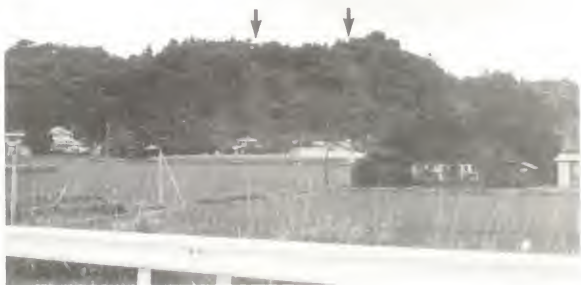
Figure 9.5 Rock falls (arrows) in steep bluffs bordering flood plain near mouth of Naruse River.

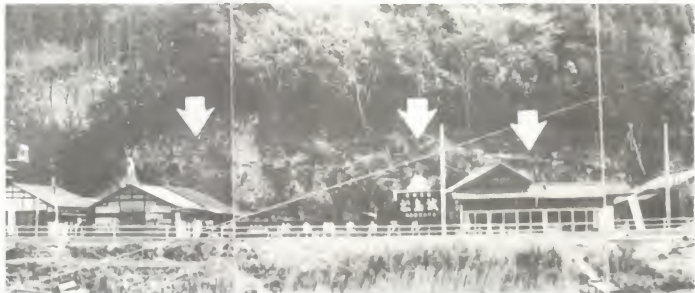
Near Atago in Matsushima, approximately 1.0 km east of the Site No. 1, rock falls from tuff, similar to the tuff forming the larger rock fall at Site No. 1, damaged outbuildings near three houses. About 500 m<sup>3</sup> of debris was shaken from cut slopes 15 m in high beneath which houses and storage buildings were closely juxtaposed (Figure 9.6). Most of the damage was not to the houses proper but to attached storage sheds and outbuildings as shown in Figure 9.7.

**Figure 9.6** Panoramic view of houses damaged by rock fall from adjacent cut slope in tuff\*. Rightmost arrow points to area shown in figure 9.7. (Photograph courtesy of Y. Tsuruya).

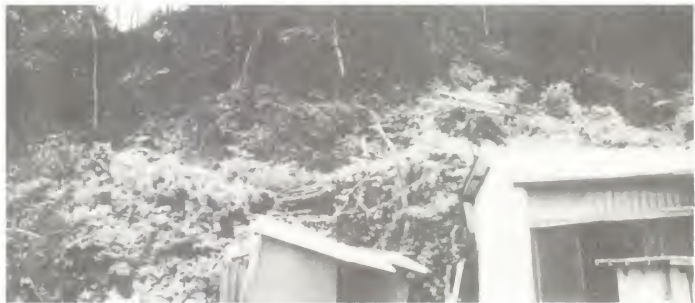
**Figure 9.7** Closeup of rock fall and damage to buildings shown in right-hand portion of figure 9.6. (Photograph courtesy of Y. Tsuruya)

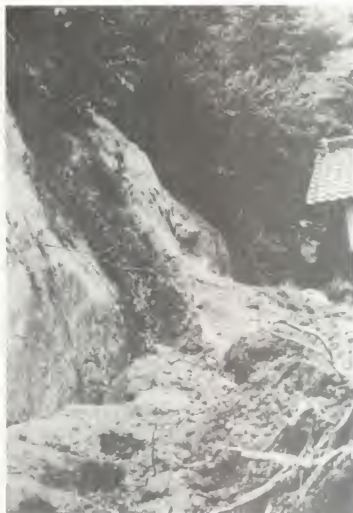
Approximately 3 km east of Atago in Mototetaru, Matsushima, small rock falls occurred in tuff-breccia deposits, damaging several storage buildings adjacent to houses. Failures occurred along a section of cut slope about 100 m in long and produced about 200 m<sup>3</sup> of debris. The slope is 10-13 m high and is inclined at about 60°. One rock fall and a scarp exposing tuff breccia is shown in Figure 9.8.

Figure 9.8 Rock fall from steep slope in pumiceous tuff breccia near Mototataru. Failure was about 200 m<sup>3</sup> in volume. (Photograph courtesy of Y. Tsuruya)

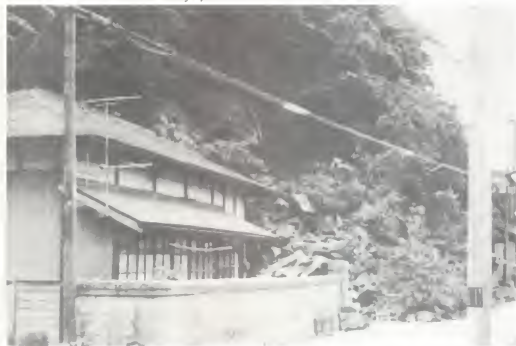
At Kakinoura in Matsushima, about 100 m<sup>3</sup> of blocky debris was produced by a seismic-induced rock fall in tuff that damaged a concrete wall adjacent to a house. This rock fall occurred on the nose of a narrow ridge of about 35 m local relief. The slope failed along pre-existing fractures or joints and produced blocks of debris as long as 1.0 m. The size of the blocks reflects the fracture spacing of the rock. The rock fall and the house adjacent to the damaged concrete wall are shown in Figure 9.9. Two other small rock falls nearby did minor damage to walls of three other houses.

Figure 9.9 Rock fall in Miocene tuff causing damage to concrete wall adjacent to house. (Photograph courtesy of Y. Tsuruya)

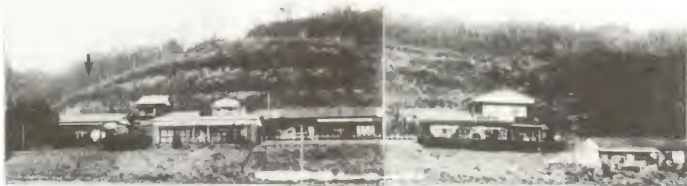
At Kitashionai, Murata, 25 km southwest of Sendai, another steep slope in tuff failed, generating a small rock fall damaging one house. Figure 9.10 shows several houses near the nearly vertical cut slope about 15 m high. One of these houses suffered damage to a retaining fence and part of the roof. A closeup of the rock fall and roof damage is shown in Figure 9.11.

Figure 9.10 Panorama of cut slope near Kitashiona in Miocene tuff which produced rock falls during earthquake damaging nearby houses. Arrow points to damaged house shown in closer view in figure 9.11. (Photograph courtesy of Y. Tsuruya)

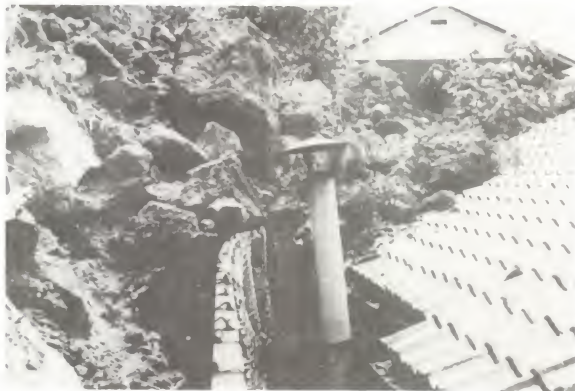
Figure 9.11 Rock fall damage to retaining wall and roof of house in left-hand portion (arrow) of figure 9.10. (Photograph courtesy of Y. Tsuruya)

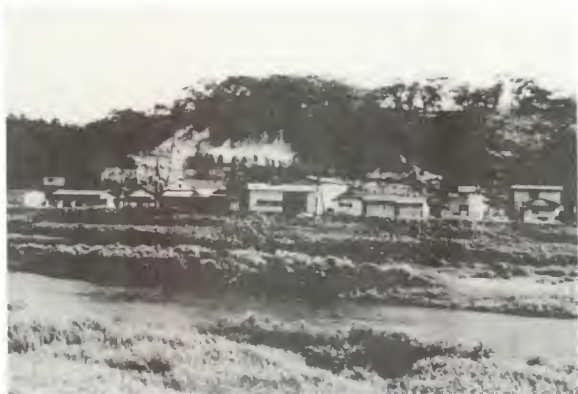
Figure 9.12 Steep slope near Hebinumayama in heavily fractured tuff which underwent failure as rock falls damaging portions of houses in front of the slope.

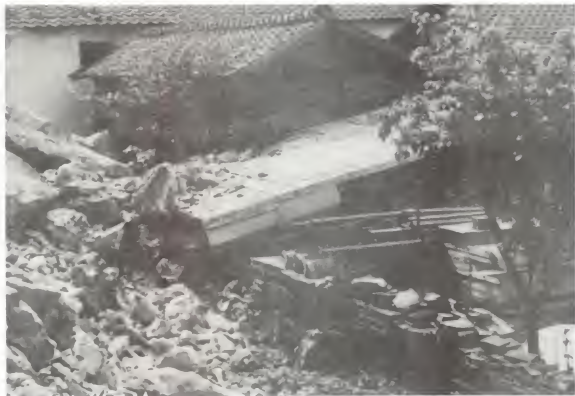
A rock fall of approximately 1000 m<sup>3</sup> occurred at Hebinumayama, Sanbongi, on a 20 m high, 110 m long, nearly vertical cut-slope no more than 10 m from five houses at the base of the slope (Figure 9.12). The falling rock did minor damage to two houses and attached storage sheds (Figure 9.13). Rock fall occurred along the entire length of the slope which is composed of a bedded tuff containing numerous fractures. Here, as at Kakinoura, failure took place along the pre-existing fracture surfaces. Block size of the debris ranged from several centimeters to several meters.

Figure 9.13 Rock fall from slope shown in figure 9.12 impinging on storage shed next to slope.

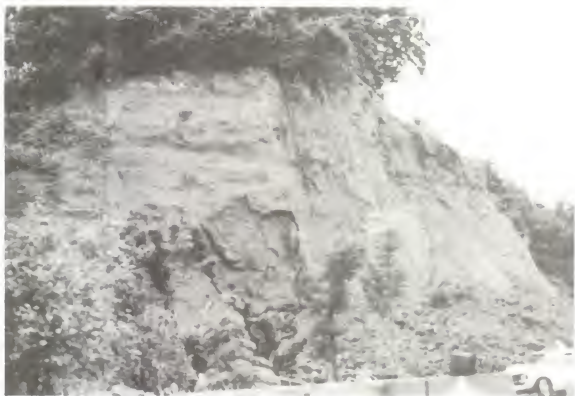
A typical roadcut failure (Figure 9.14) was derived from weakly cemented sandstone along a valley west of the Naruse River. The rock fall is less than 1 m thick, and slope height is about 10 m.

Figure 9.14 Rock fall from roadcut in weakly cemented sandstone.

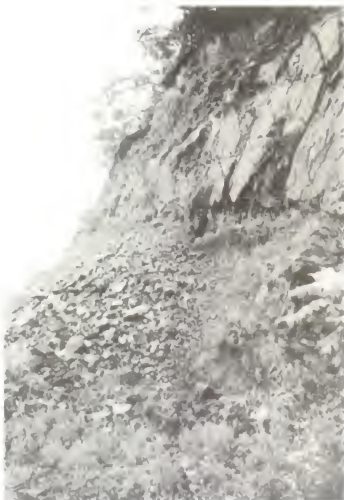
A rock fall in Triassic slate and fine-grained quartzite occurred on a steep roadcut slope on the north side of the New Kitakami River. The scarp of the rock fall is inclined at about 60° and is formed by prominent slaty cleavage planes (Figure 9.15). The blocky debris broke into pieces of up to 30 cm in longest dimension. Almost all of the debris consisted of blocks that had separated along pre-existing fractures.

Figure 9.15 Rock fall in roadcut. Note slaty cleavage planes that form the rock fall scarp.

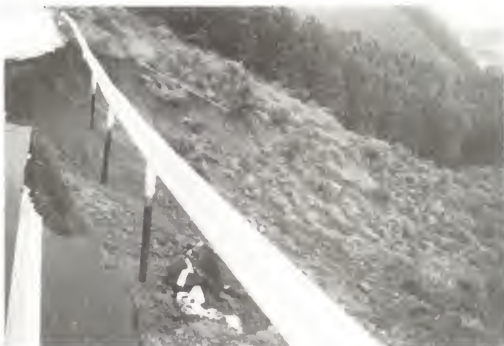
Several artificial fill failures occurred on roads on the Ojika Peninsula; one such failure is shown in Figure 9.16. The fill material slumped away from beneath the road surface and formed a scarp cutting about 2 m into the highway. The fill appeared to be either uncompacted or poorly compacted sandy clay derived from adjacent bedrock and soil. This failure occurred at a site where rainfall-induced slumping had occurred repeatedly before the earthquake (T. Tazaki, 1978, oral communication). At the time of the visit, plastic sheets had been spread over the extensively cracked pavement to prevent or minimize rainfall infiltration into the scarp area. During observation, heavy rainfall was mobilizing the debris into small mudflows.

Figure 9.16 Slump in artificial fill along a highway on the Ajika Peninsula.

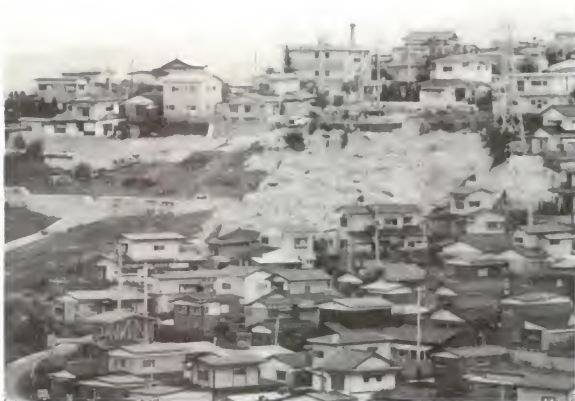
Figure 9.17 Rotational slump in artificial fill in Sendai (area covered by tarps) which destroyed one house and is threatening others. To left of slump is concrete slope protection dam (sabo works).

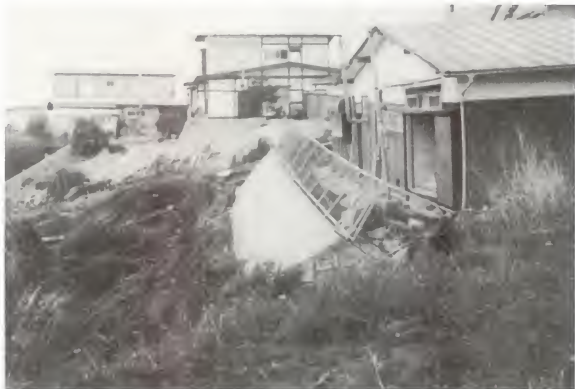
Figure 9.18 House near head of slump. House was removed due to undercutting by headwall scarp (Photograph courtesy of Y. Tsuruya).

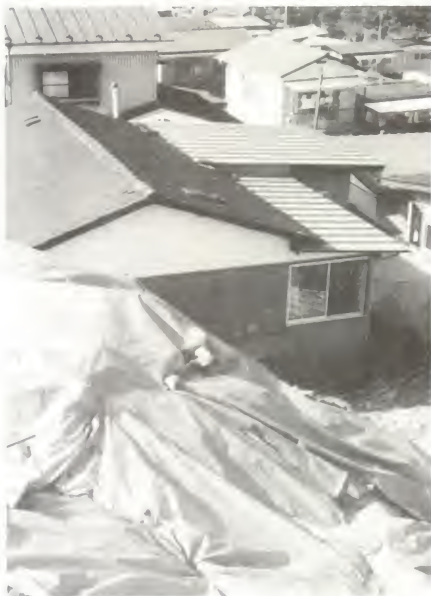
**Figure 9.19** Toe of slump and house below in danger of being overridden by slide mass. House has been evacuated.
